Archeological Excavations
at the
Mariah Wright House South Chimney
Appomattox Court House
National Historical Park

Allen H. Cooper
Chesapeake and Allegheny System Support Office
May 1996

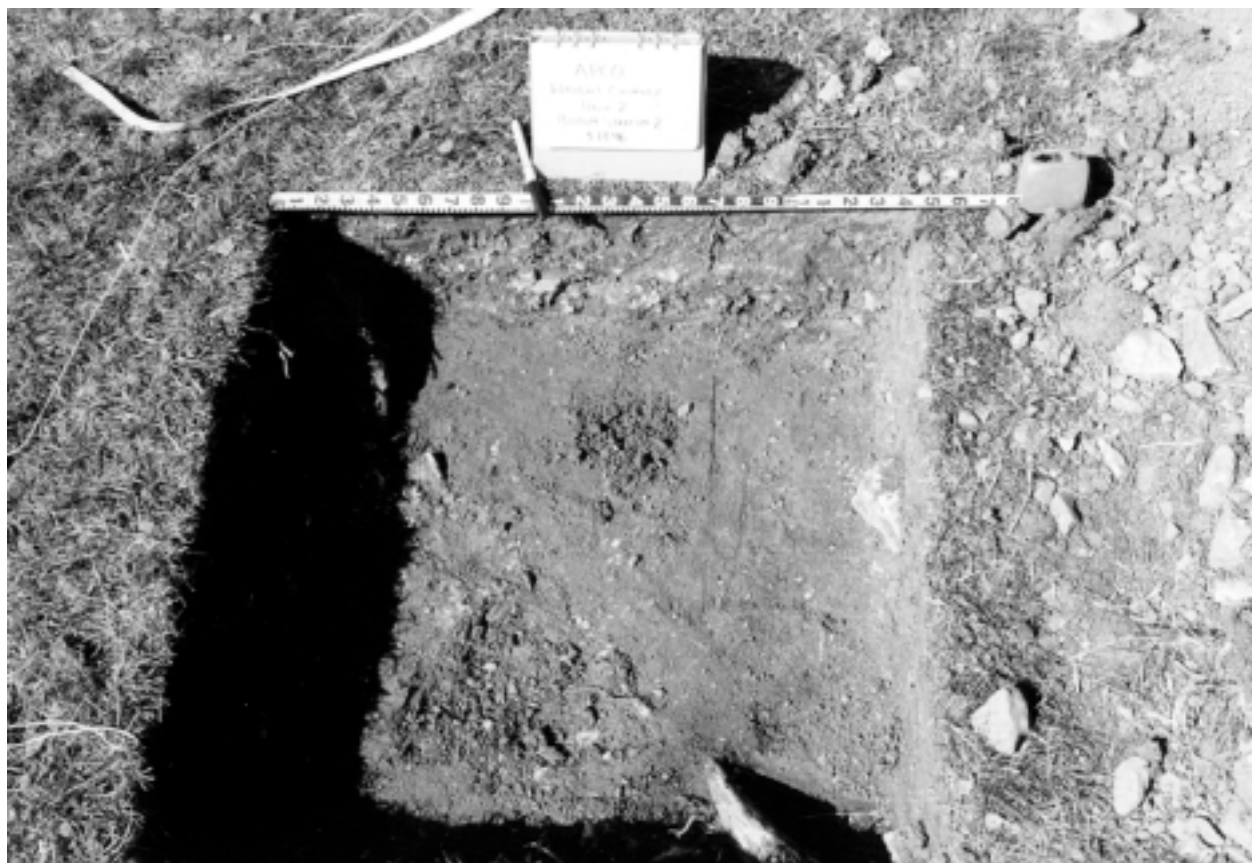
Figure 5: Unit 2, Base of Stratum 2 showing Disturbance.

Unit 2 is located 2.5 feet south of the south border of Unit 1, or five feet south of the chimney base (Figure 1). Possessing four strata, it also contained an extensive disturbance from installation of the foundation perimeter drain (Figure 5).

Stratum 3 appears at 0.95 feet below datum, containing a feature traversing the entire unit from the northwest to the southeast (Feature 1). The stratum is composed of reddish-brown sandy clay. Consultation with the facility manager indicated the feature was the drain line installed during the reconstruction in 1965. In the northeast half of the unit, Stratum 3 continues to 1.1 feet below datum. Stratum 3 was screened while the feature was not. Stratum 3 contained no artifacts and is equivalent to Stratum 4 in Unit 1.

Stratum IV (Stratum V in Unit 1) appears across the northeast half of the unit at 1.1 feet below datum and represents the sterile subsoil base composed of reddish-brown clay. The disturbance feature continues to an unknown depth.
